**IN THE COURT OF APPEAL OF THE REPUBLIC OF SINGAPORE**

**[2023] SGCA 20**

Court of Appeal / Civil Appeal No 45 of 2022

[Admiralty and Shipping — Collision]

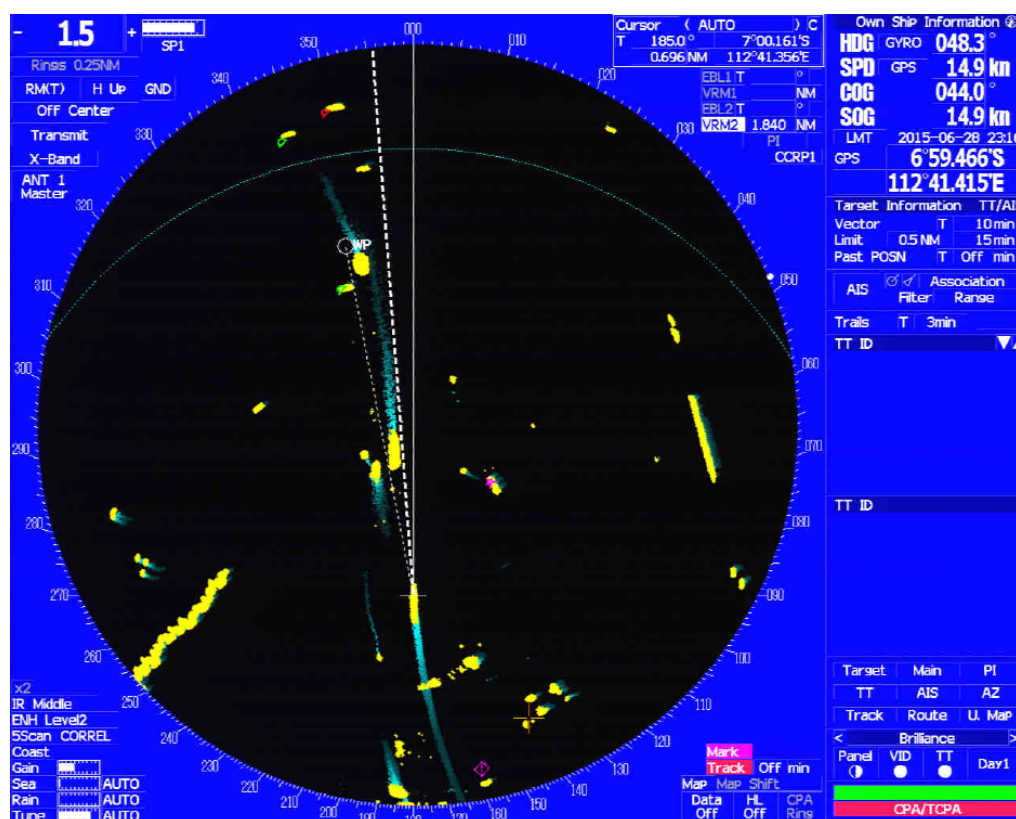
197 The screenshot taken 30 seconds later at 23:16:44 hours (reproduced below) shows the *LP*’s radar echo now lying *port* of the *NA*’s COG line, as vessels shaped to pass port-to-port. This was just before the port sheer commenced at 23:16:46 hours.
