Airtrust (Hong Kong) Ltd v PH Hydraulics & Engineering Pte Ltd  
[2015] SGHC 307

**Case Number** : Suit No 219 of 2013  
**Decision Date** : 30 November 2015  
**Tribunal/Court** : High Court  
**Coram** : Chan Seng Onn J  
**Counsel Name(s)** : Tan Chuan Thye SC, Avinash Pradhan, Alyssa Leong and Arthi Anbalagan (Rajah & Tann Singapore LLP) for the plaintiff; Daniel John and Kevin Cheng (Goodwins Law Corporation) for the defendant.  
**Parties** : AIRTRUST (HONG KONG) LTD — PPH HYDRAULICS & EENGINEERING PTE LTD

*Commercial Transactions – Sale of Equipment – Breach of Contract*

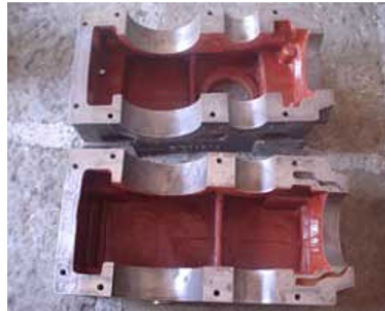
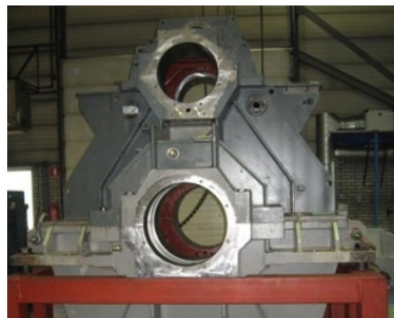
provides a rigid base to seat and support the bearings whilst under load and provides an accurate machined datum, consequently giving better alignment of the bearing to the outboard mounting of the pinion. A similar arrangement is also appropriate for the bearing housing for the main driveshaft. This is critical to ensure correct alignment of the pinion gear to the spur gear. A similar arrangement appropriate for the bearing housing for the main driveshaft is also critical to ensure correct alignment of the pinion gear to the spur gear. In his report, he showed the following examples of correctly designed bearing and gearbox housings.

117 In the light of Mr Moore's criticisms of the design from a conceptual perspective, Mr Hooper conceded that the whole bearing housing could be better designed and it was "*definitely not an optimum housing arrangement.*" In fact, the Defendant had shown no technical justification from departing from what one would normally expect for such a design. There are no calculations or engineering analyses on record in the Defendant's possession that would support the sufficiency or structural robustness of the Defendant's design. I therefore find that the Defendant had not given due consideration to whether the bearing housing was appropriately designed *at the time it was designed.*
