**IN THE GENERAL DIVISION OF  
THE HIGH COURT OF THE REPUBLIC OF SINGAPORE**

**[2025] SGHC 66**

**JUDGMENT**

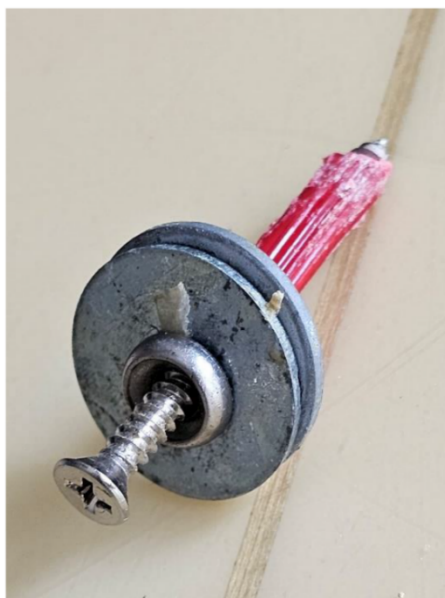
components jointly as the “Screw”. I reproduce a photograph of the Screw below, for illustrative purposes:<sup>46</sup>

62 Mr Lorinet submits in his closing arguments that the primary issue is “not the suitability of the wall but rather [Helu-Trans'] choice of inadequate fastening materials, specifically the 5 cm screw that was too short and too narrow in diameter to safely secure the Sculpture.” It is then said that “[a] wall's theoretical capacity to support weight is irrelevant when the Sculpture has already fallen due to the use of an inadequate screw.”<sup>54</sup> These are question-begging arguments: given that the Screw itself emerged unscathed from the incident, the adequacy of the Screw that Helu-Trans had used can only be assessed in relation to the capacity of the surrounding materials to withstand the various forces that acted upon them. I am also mindful that Dr Tan never

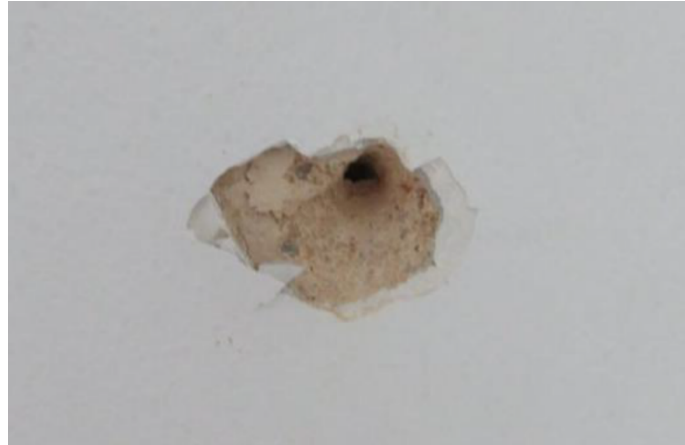
55 Apart from the Screw and the Sculpture, there is also the Wall itself. I reproduce a photograph of the fixation point following the fall of the Sculpture:<sup>48</sup>

58 In assessing the evidence, I begin with the one conclusion that can be made with sufficient certainty: the photographs indicate – and the parties’ experts are agreed<sup>51</sup> – that the fall of the Sculpture was a direct consequence of the failure of the Wall (and not any part of the Sculpture or the Screw).

60 The wall material is subjected to two types of compressive forces. The first is the outward force of the rawl plug as the screw is driven deeper into it, causing it to expand. The second is caused by the downward (or shear) force on the screw due to the weight of the Sculpture. This is resisted by the lower part of the hole. If the combination of these forces exerts a pressure on the wall material that is higher than the compressive strength of that material, then it will fail, or in ordinary parlance, be crushed. Upon crushing, which typically occurs at the start of the hole where the compressive force is the highest, the hole

expands in size and no longer provides the frictional force that prevents the plug from being pulled out.<sup>52</sup> The photograph of the damaged Wall reproduced at [55] above shows that this was indeed what had happened. This was confirmed by the parties' experts at trial.<sup>53</sup>
